# USER ARTICLE PANEL - TWISTING

**Version 2026.1**

**SCOTTSDALE**

# PANEL - TWISTING

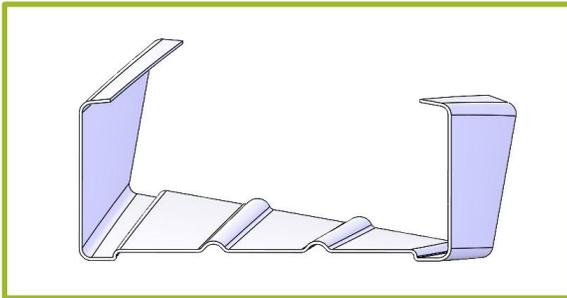
Panel Machine is producing C-profile frames with a twist in the bottom horizontal section. The twist caused misalignment in production, leading to quality issues in the final frames.

- Roller misalignment in entry and mid-stations.
- Incorrect pressure setup.
- Worn bearings or rollers in Station 4.
- Different Lip lengths.

- Checked and re-aligned rollers at Stations 1–3, which set the direction of the profile.
- Checked and reset roller setup ensuring rollers are level with even pressure side to side.
- Replaced worn bearings or rollers at Station 4.
- Adjust infeed rollers to even out lip lengths.
- Verified machine setup for the steel thickness in use.

- Always perform a full roller setup when changing material thickness.
- Check station 1-3 for alignment.
