SERVICE PUNCH DEFORMING

HOLES

Version 2026.1

SCOTTSDALE

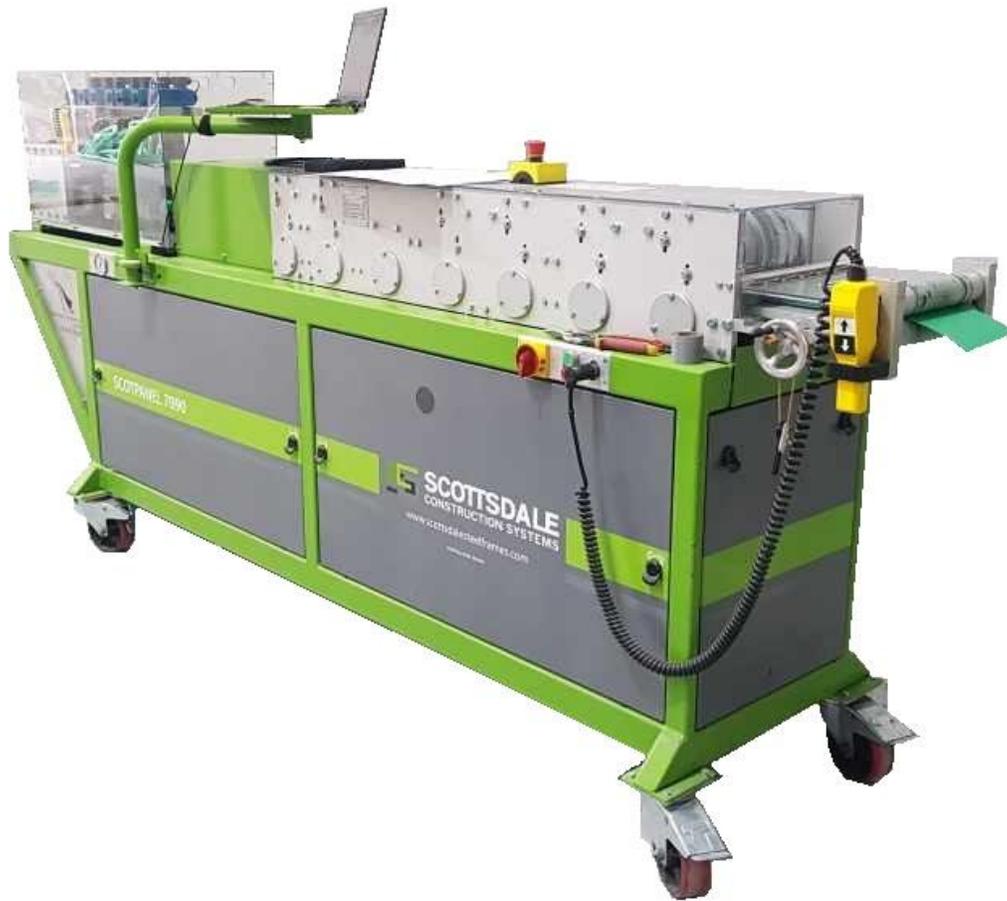
Service punch deforms the hole when running automatically with the rollformer but works correctly in manual mode.

- Punch not fully seated or tightened.
- Hydraulic oil pressure too low, causing slow punch retraction.
- Cold oil conditions increasing viscosity and slowing punch speed.

- Verify that the punch is fully seated and locked in place.
- Inspect the hydraulic pressure gauge while running a service punch operation.
- Ensure system oil pressure matches factory specifications.
- If operating in cold environments, warm up the oil before starting production to restore correct punch speed.
