# USER ARTICLE ALIGNING TOOLHEAD

**Version 2026.1**

**SCOTTSDALE**

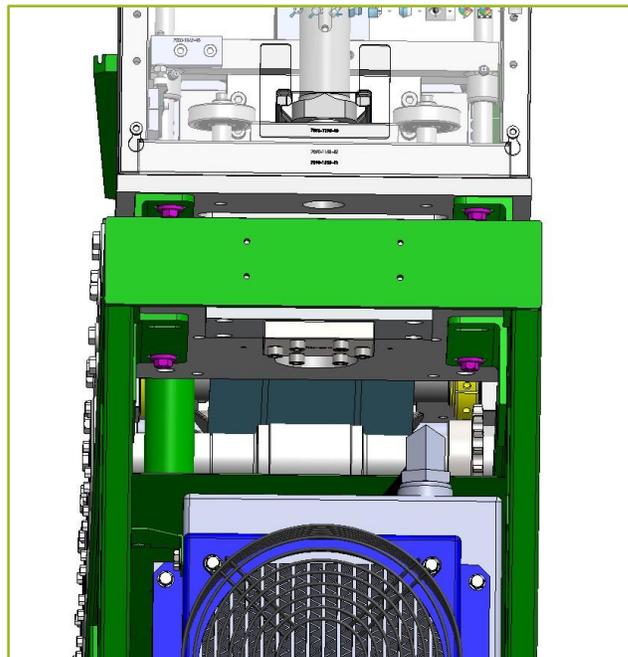
There are 4 Bolts highlighted in Purple in the above picture that holds the tool plate to the main frame of the rollformer. A 16mm spanner should fit these bolts.

Loosen off these 4 bolts and manual feed material through. After you have fed roughly 500mm to 1000mm through you can re tighten these bolts be careful not to move the tool plate while tightening them.

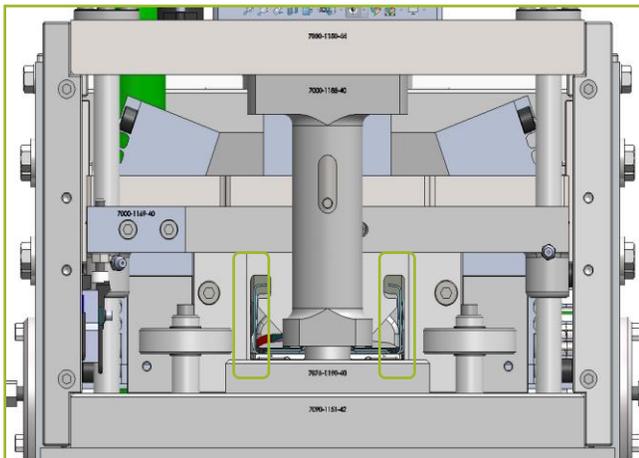
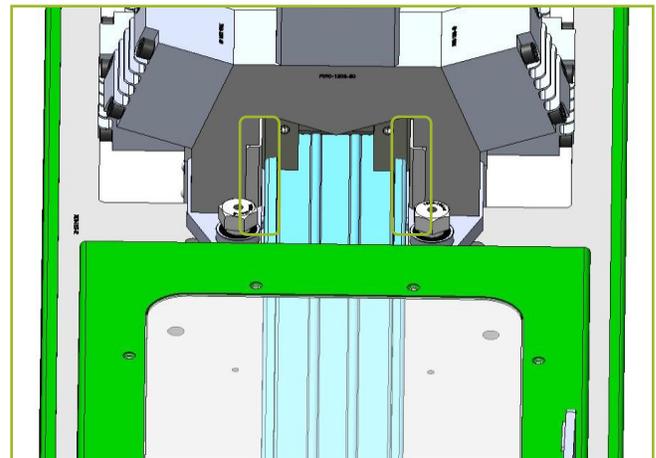
Looking at material exit of the toolhead and the material at toolhead entry as indicated in the following pictures you can judge by eye if the material is centered to the toolhead.
